## 1966 Chevrolet Corvair homecoming – The good news and the bad news

[Don Homuth](#) on Mar 6th, 2019

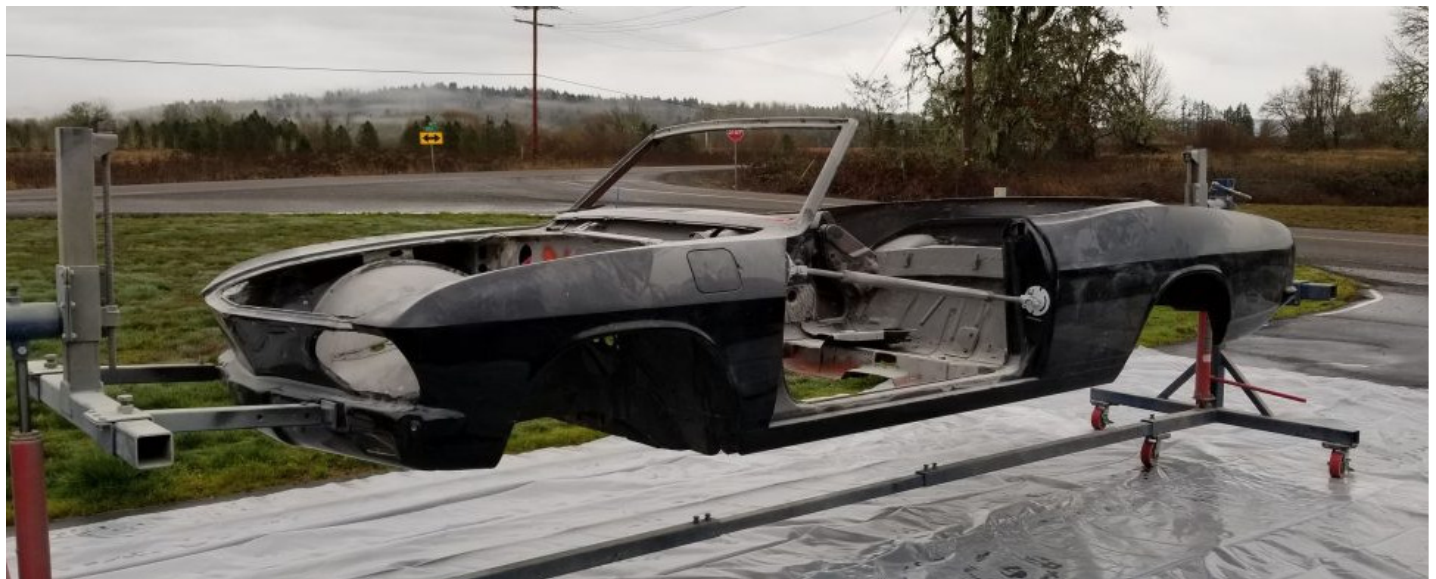
*The Corvair's body shell awaits bead blasting. Photos by author.*

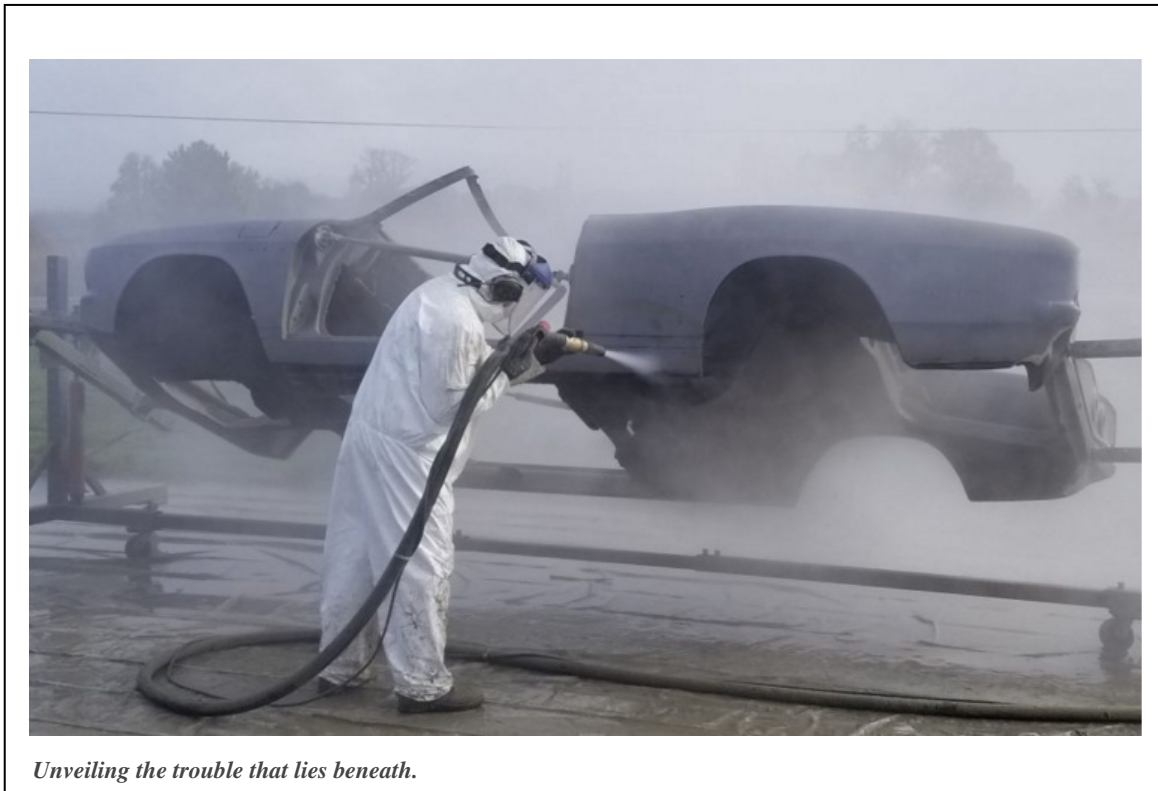
*Unveiling the trouble that lies beneath.*

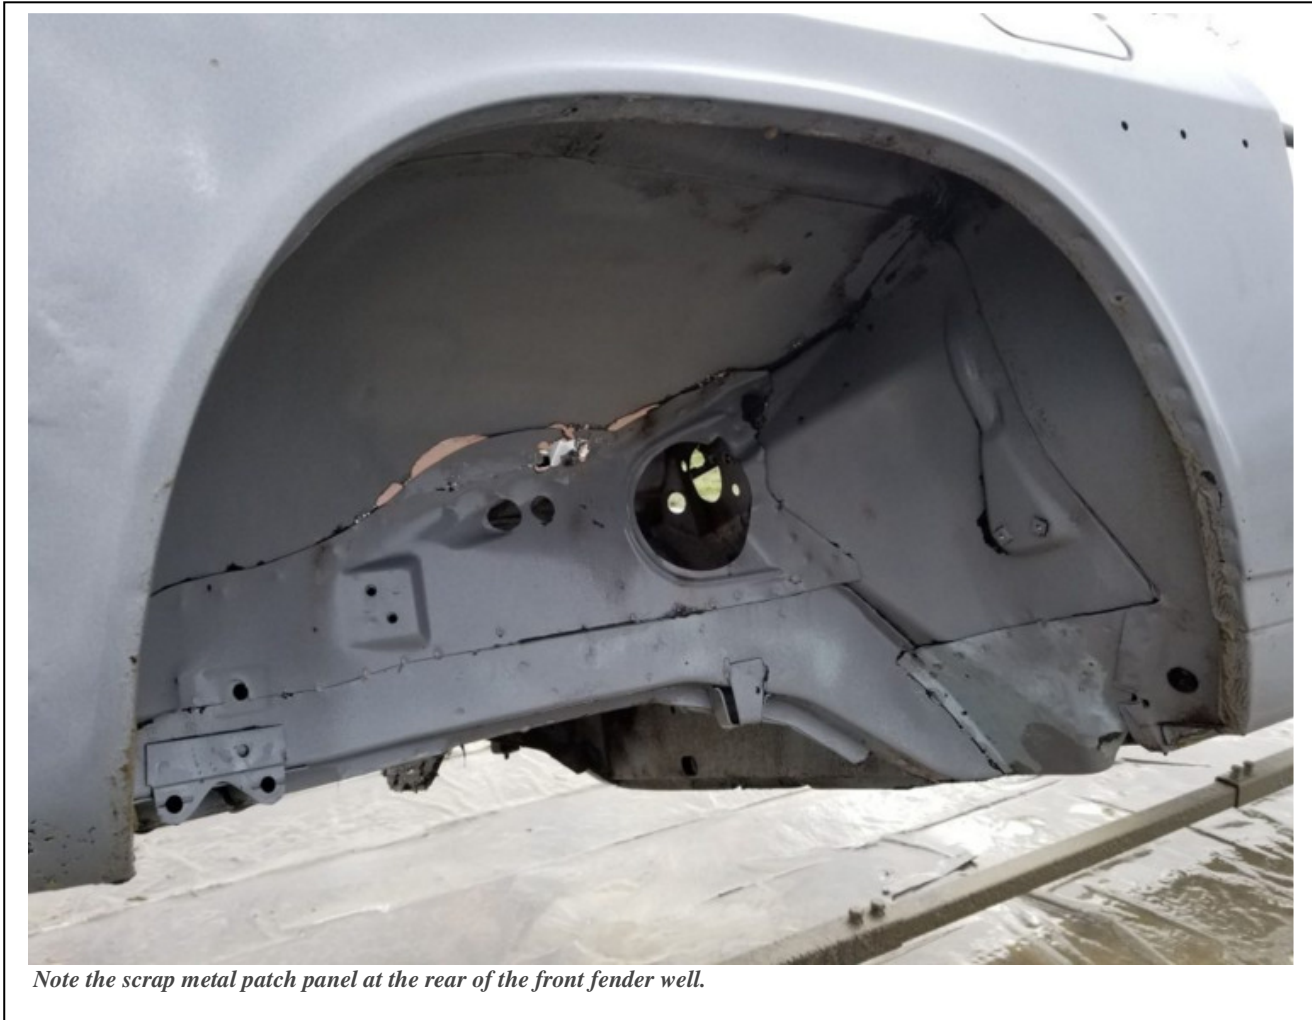
The first pass with a wire brush revealed some of the wheel well corrosion that got covered up with a thick layer of Bondo. Everything pretty well stopped at that point while I took a longer closer look at everything else. It was enough to raise some considerable suspicions about what I might find. So I had it partially blasted.

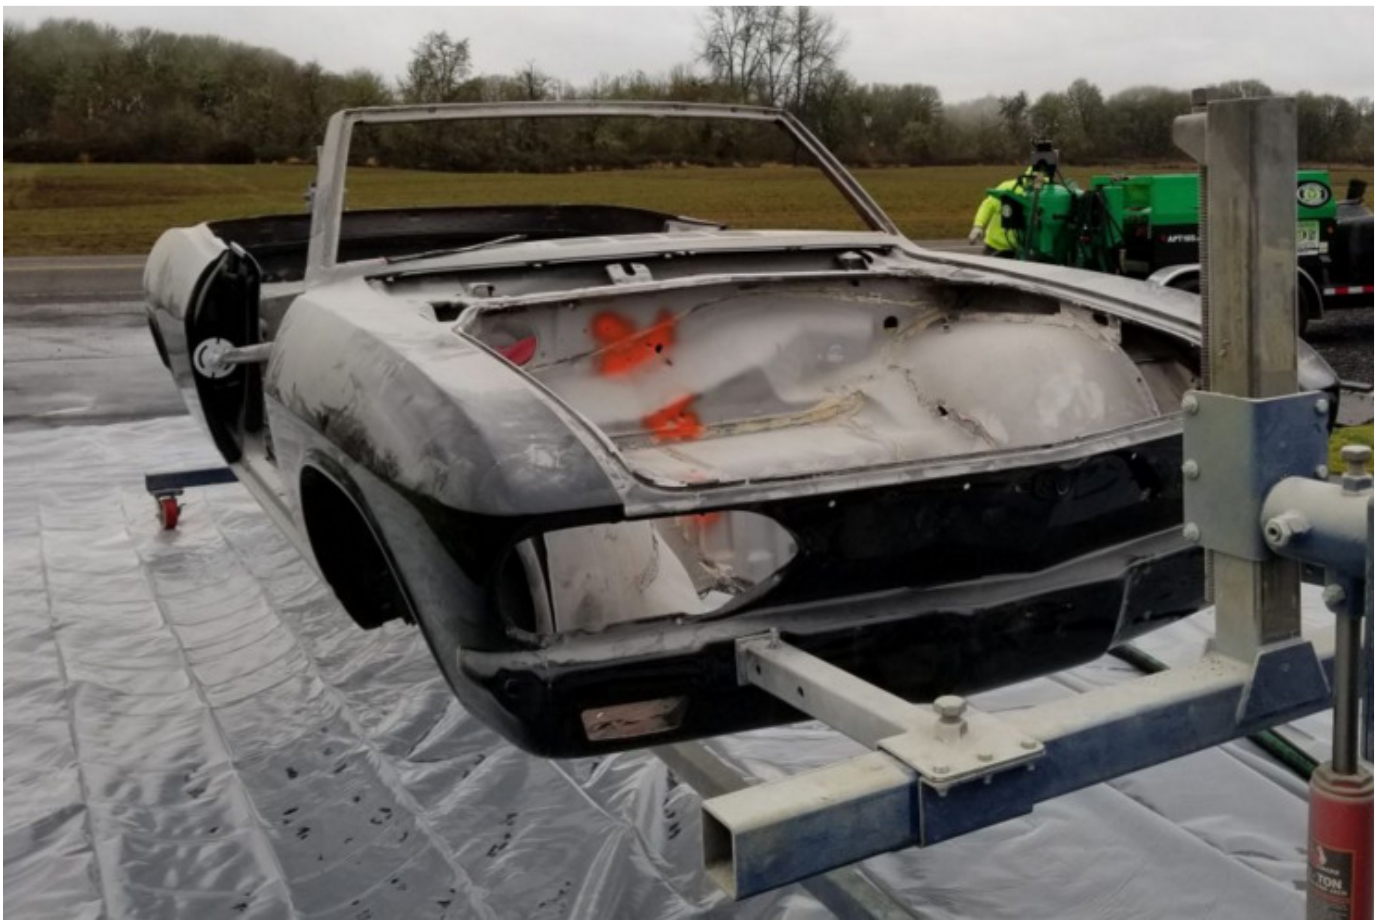
I had no idea that the floor was so corroded that it would not be safe for the bolts to hold the seats securely. Under the back seat was nearly as bad. The front fender wells were corroded through both layers of metal. The bullet holes in the cowl were a surprise.

*Bullet holes (marked with orange spray paint) were not a standard feature on the '66 Corvair.*

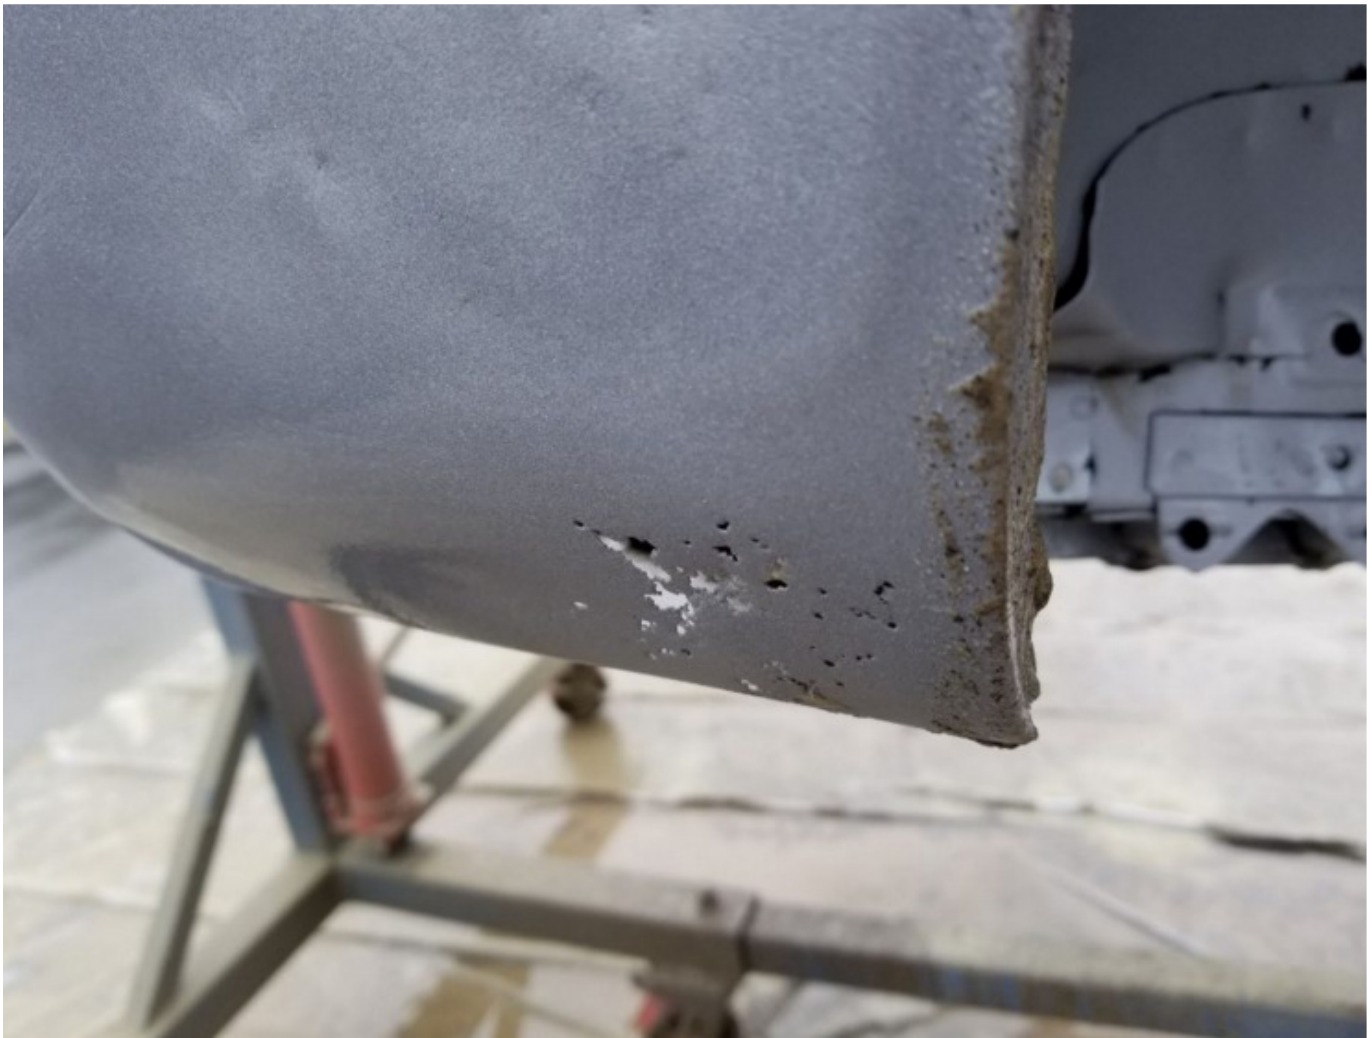
*The right rear quarter panel will require patching.*

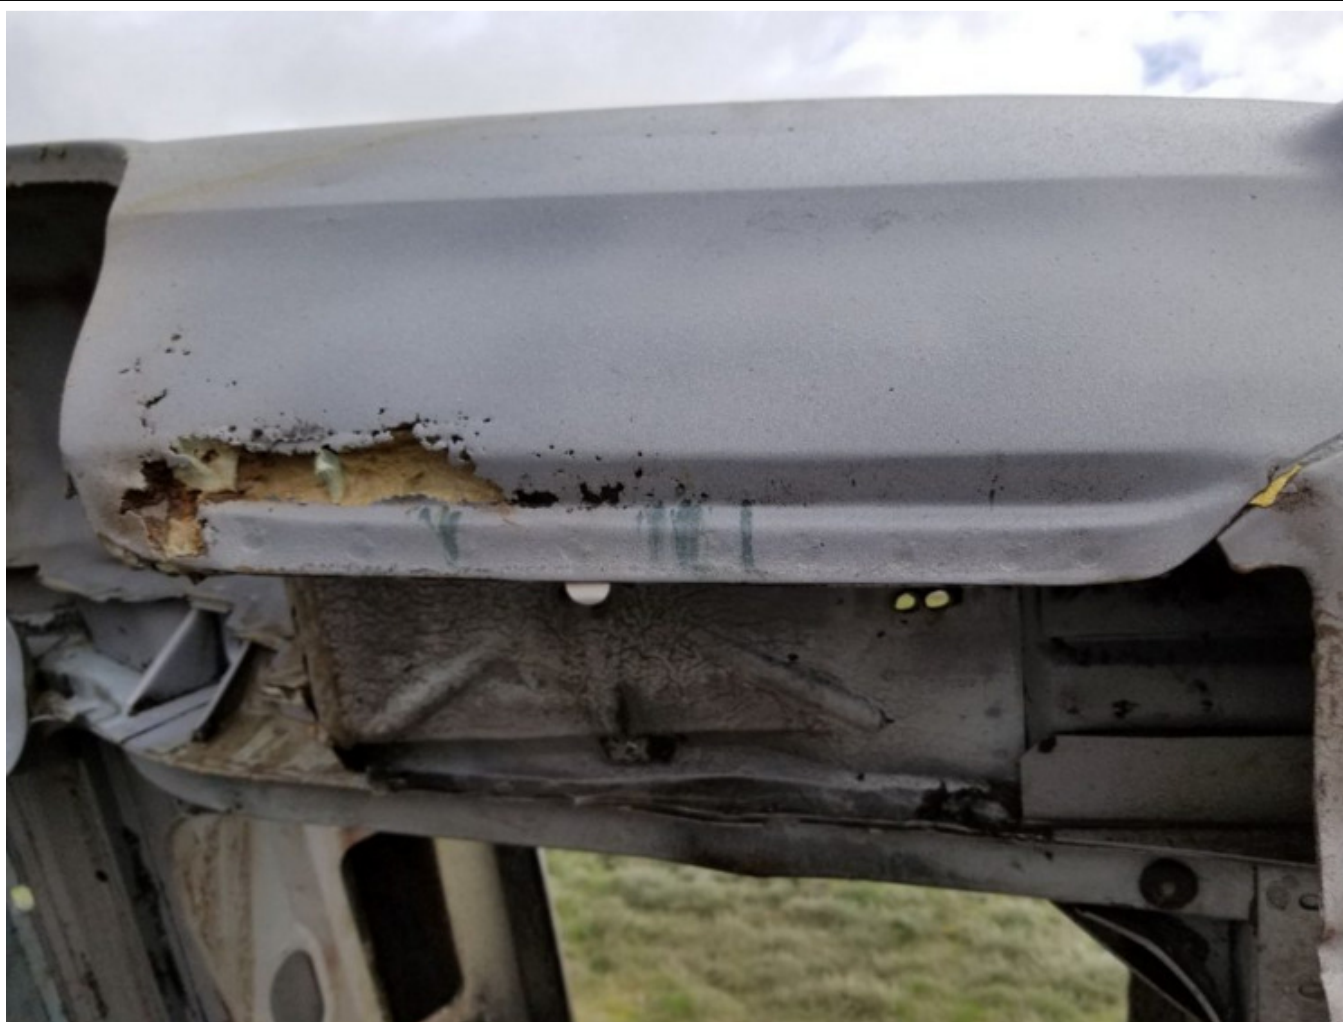
*And so will the left rear quarter panel.*

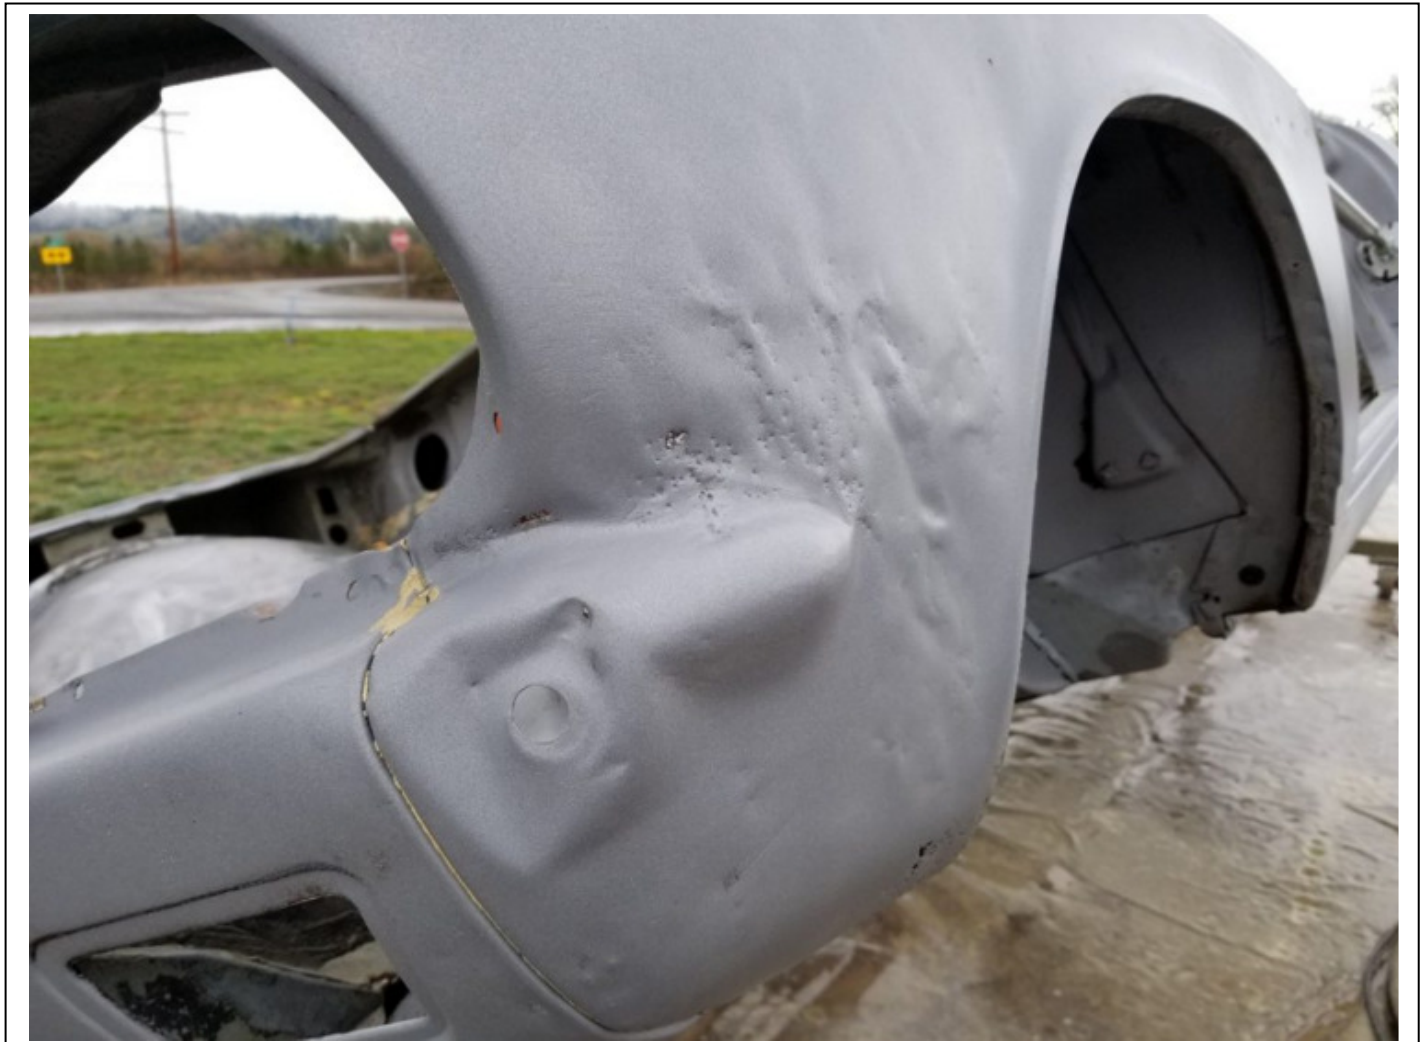
*Evidence of a past collision repair, likely done to a price instead of a standard.*
