Corvan Antics

July/August 2012
Volume 40 Issue 4

Corvanatics

Chapter 001 Of the Corvaire Society of America
The Forward Control Corvaire People

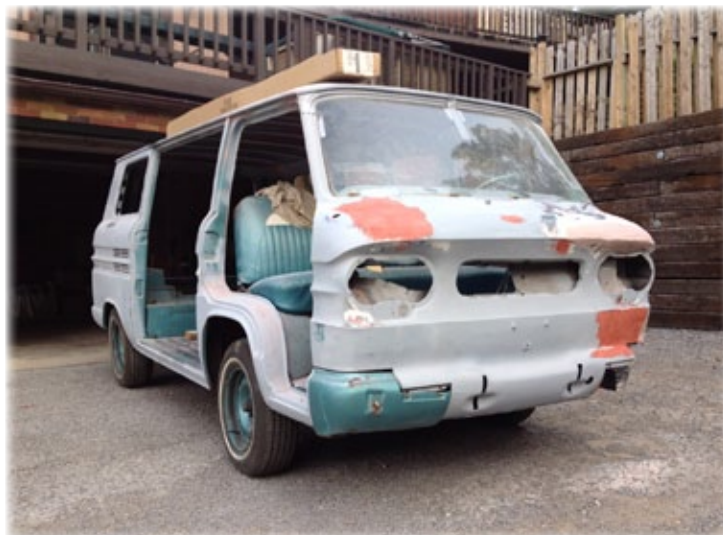
S-10 Air Dam on Valveeta by Dave Palmer

I have had this Air-Dam installed on my Greenbrier "Valveeta" for quite a while. It is from a late 1980's Blazer. I was smart enough to buy 2 of these new from a dealership back then, so I have another one to mount on the Rampside after it gets painted.

I cut off the top lip of the Air-Dam to allow it to be reshaped a bit to the FC. Next I made steel bars to shape the ends and give support to the mounting surface of the outer sides of the unit. These are pop-rieveted to the plastic Air-Dam. In one of the photos this metal is visible in the outside corners... sorta! Now mounting the Air-Dam to a FC that has little to mount to was a little challenge. What I did was make up 8 brackets out of 1/2 inch aluminum angle material. Each angle bracket is about 2 inches long. These are mounted on the lower body lip of the FC. A sheet metal screw "I used stainless" is ran up through the body lip edge and into the angle bracket to make 8 flat surfaces to bolt the Air-Dam to. A little drilling of the brackets and the metal supports along with some careful measuring and 1/4-20 bolts hold the unit in place.

You have to be careful where the steering comes close to the front lower body panel at full lock. Do not obstruct it here. Also... there is no lower tin front cover panel on My Brier. Most don't have them anyway. That is a rare part... however... FYI... Californis Corvairs has some nicely reproduced. This tin, covers all the tie rod ends and looks clean but also makes lubricating the steering a bit more of a job. If I had this tin cover, I would not be able to install the Air-Dam the way I did.

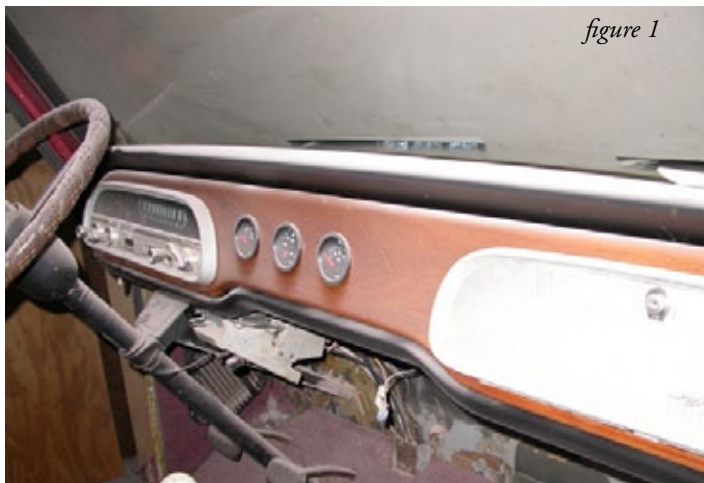
As restoration of my '61 GB progressed, I inevitably had to deal with the dash. When I purchased the van in 1980, the instrument panel had been cut out and replaced with a piece of cheap paneling, which matched the shag rug covering most everything else. Needless to say, grounding of gauges was intermittent at best. Sometime later I made a mahogany panel which at least was solid and looked decent (at least when not covered with dust as in the first figure). But the time had come, and not wanting to deal with a complete dash replacement, I opted to replace just the front along with the lower support bracket. While this project may be a rare necessity, possibly some of the techniques might be of use to others.

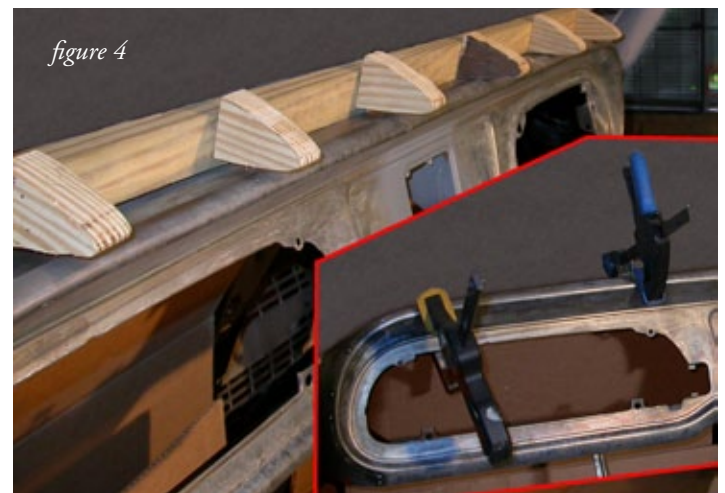
A challenging part of the repair was securely seating the edge of the new dash along the flange; because of the location, there was no way to directly clamp the joint together. To do so, I fabricated a wooden form to fit the inner contour of the dash (Figure 4). With the new front piece roughed into place, the wooden form was snugged into contour along the top of

the dash. Then the two pieces were pulled together against the form with clamps through the dash openings and air vent holes (inset). Clamps to the window posts, etc. were used to align the edges. After the replacement dash was spot welded in place the wooden bracket was removed.

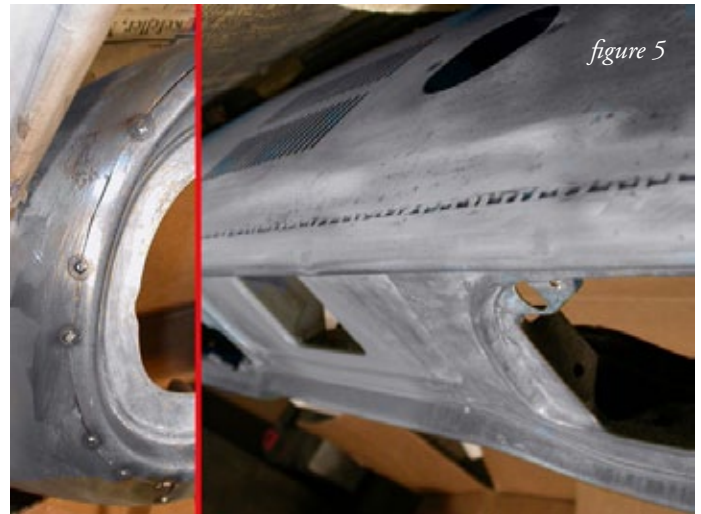
figure 5

The rest of the story is pretty routine. The edges received a continuous weld and the top was spot welded about every half inch (Figure 5; probably overkill). The dash was plug-welded at the bottom onto the support brackets. The welds were ground flush, and the seam given a little filler, and finished. Because of the location, the seam is almost invisible when viewed from the underside. The final figure shows the finished dash, ready for instrument installation.

The cuts along the edges were made using a Dremel tool with 409 cutoff wheels; it took a few, but the precision is unrivaled. The dashed line in the second figure shows the where the sides were cut, about a half-inch behind the contour ridge (dashed line). The cut across the top was made with an angle grinder since precision wasn't as important. The cut was about one inch behind the contour ridge for the replacement dash, and a half inch behind for the old dash, so that a half-inch lap would occur (see Figure 5).

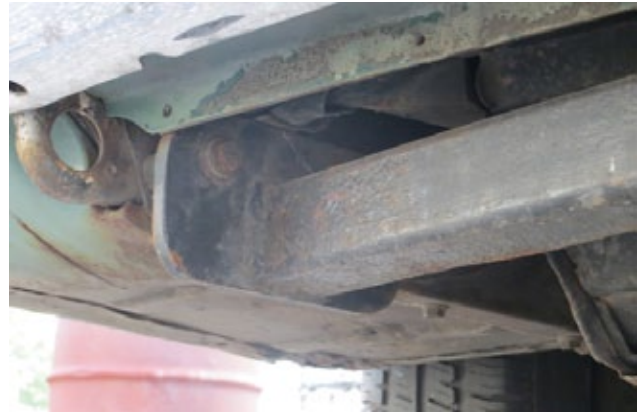
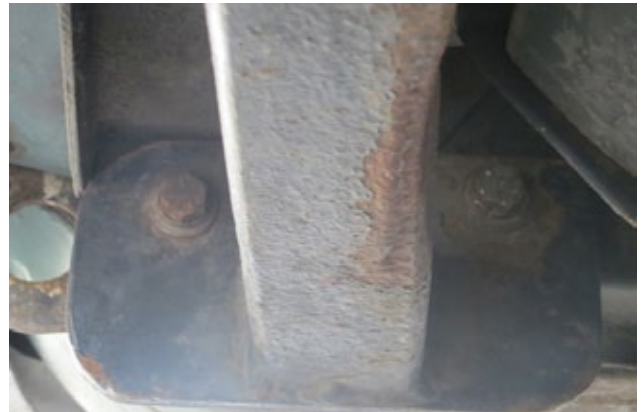
Going by memory, I created my own version of a hitch receiver. The ingredients are simple- a junkyard-found 1990's Chrysler minivan receiver and some 3/8" steel plate. The tools needed include safety glasses, a powered metal cutting saw, 4" angle grinder, and a welder.

After retrieving the hitch receiver from a minivan, it must be cut to 34 5/8" in length, making sure the actual 1.25" hitch receiver tube is centered. The two 3/8" steel plates are then cut into a 6 3/4" x 3 3/4" rectangle and the four corners of each rounded off with the angle grinder. Now remove the two lower rear bumper mounting bolts. Next, align the two plates so that they cover the bumper mounting bolt holes and are far enough back to just touch the small angle created by the rear bodywork that usually holds the valance.

The trickiest part is measuring and drilling holes in the plates to match the bumper bolt mounting holes. Once this task is accomplished, bolt both plates onto the truck with a washer separating them from the truck with the stock bumper mounting bolts. Now it is time to jack the actual receiver into place between the two plates. Be sure to check clearance on damper doors. Once situated and level, weld the three exposed sides of the hitch solid on both sides of the device. Paint and enjoy the ability to tow small trailers, use utility racks, or carry your bikes in specialized bike racks designed for hitch receivers. I have utilized my receivers on both FCs to do all of the above with great success.

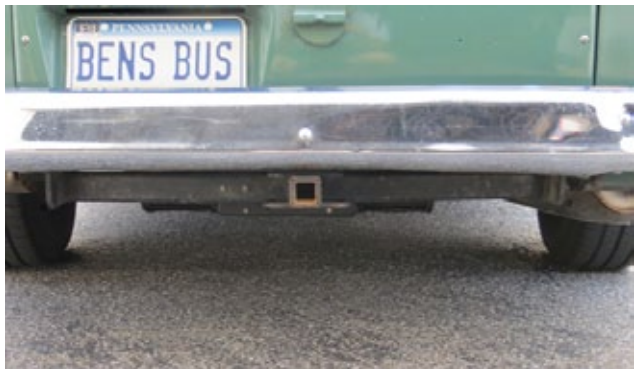
A slight re-engineering of the crossover may be necessary for clearance for the damper door. Depending on the hitch you use.
