1966 Chevrolet Corvair homecoming – progress, at last

Don Homuth on May 10th, 2019

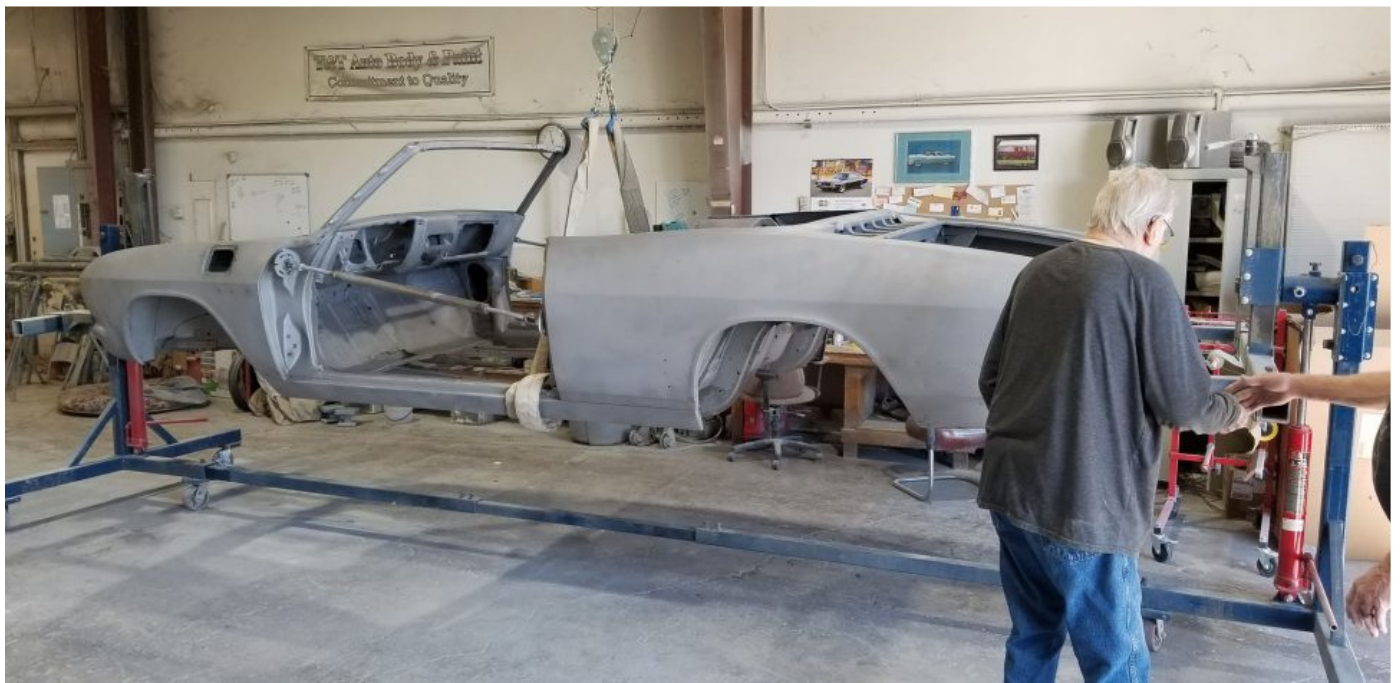
Installing the body shell — carefully — onto the rotisserie. Photos by author.

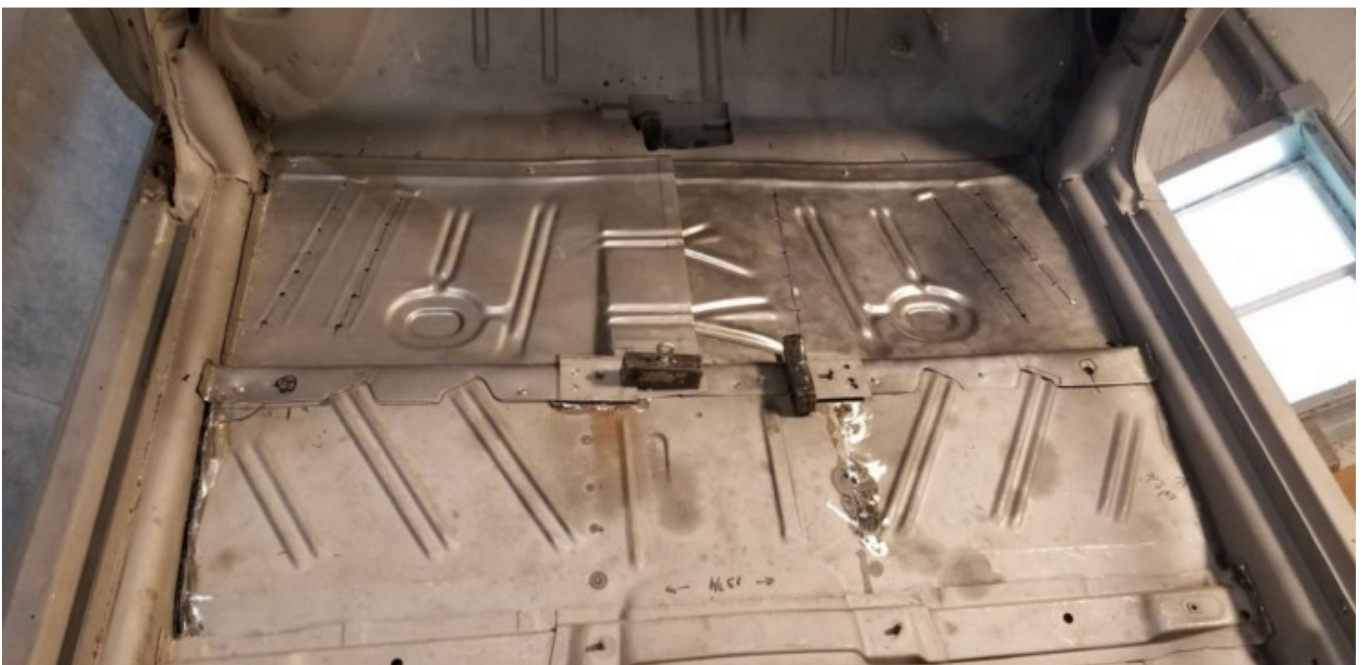
New front floor pans are welded in

The guy who has been doing much of the tin bending, welding, and replacing has had some recent medical issues, and the project has lost the last three to four weeks. Nevertheless, the new floorpans to replace the old corroded pieces are in. The floor braces underneath were blasted and properly installed. The reinforcing brackets for the seats are ready. The entire corroded piece at the bottom of the windshield will be replaced.

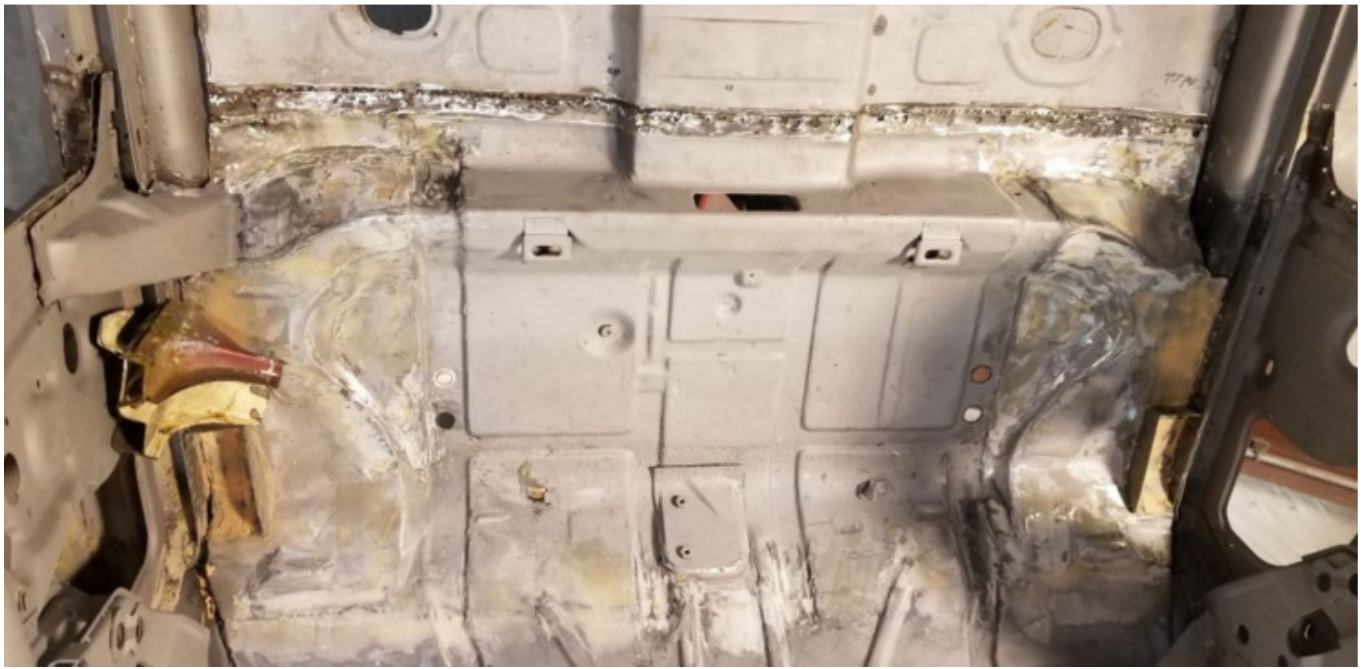
Back seat area cleanup. This was mostly okay.

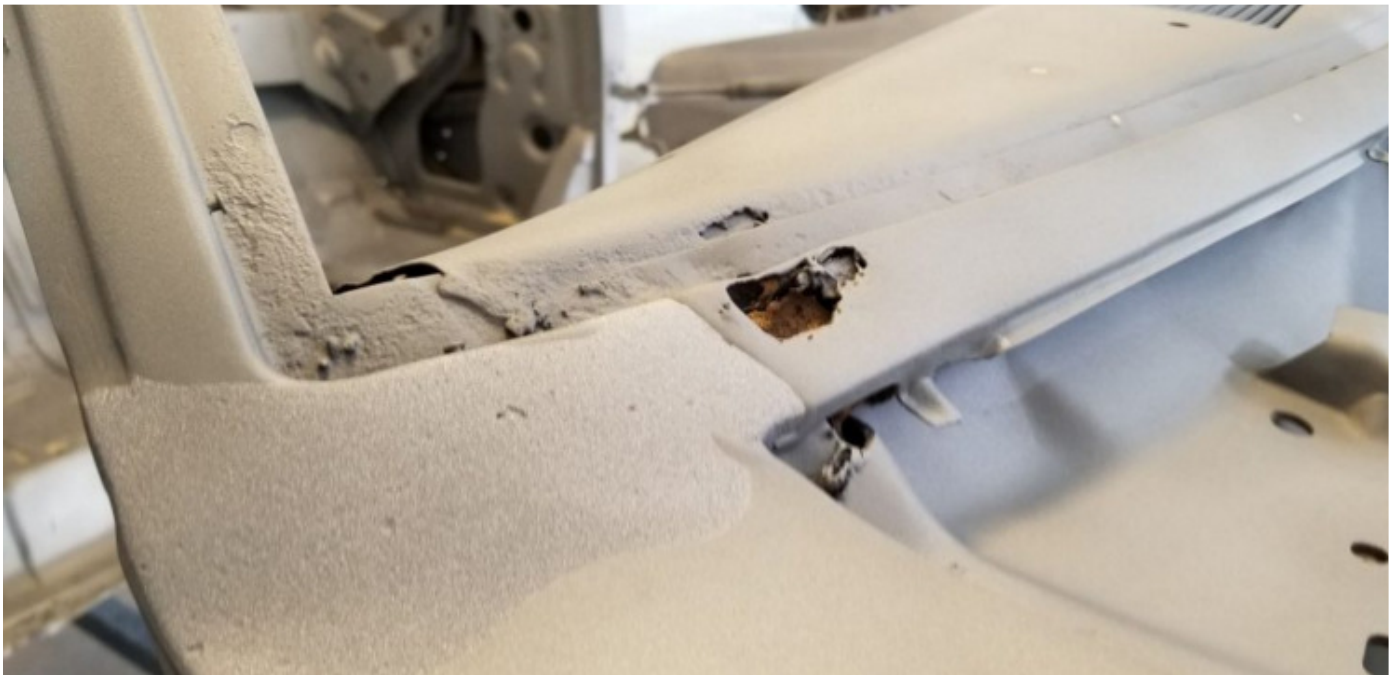
Cowl corrosion, beneath the windshield. This will be replaced with a full-width new piece

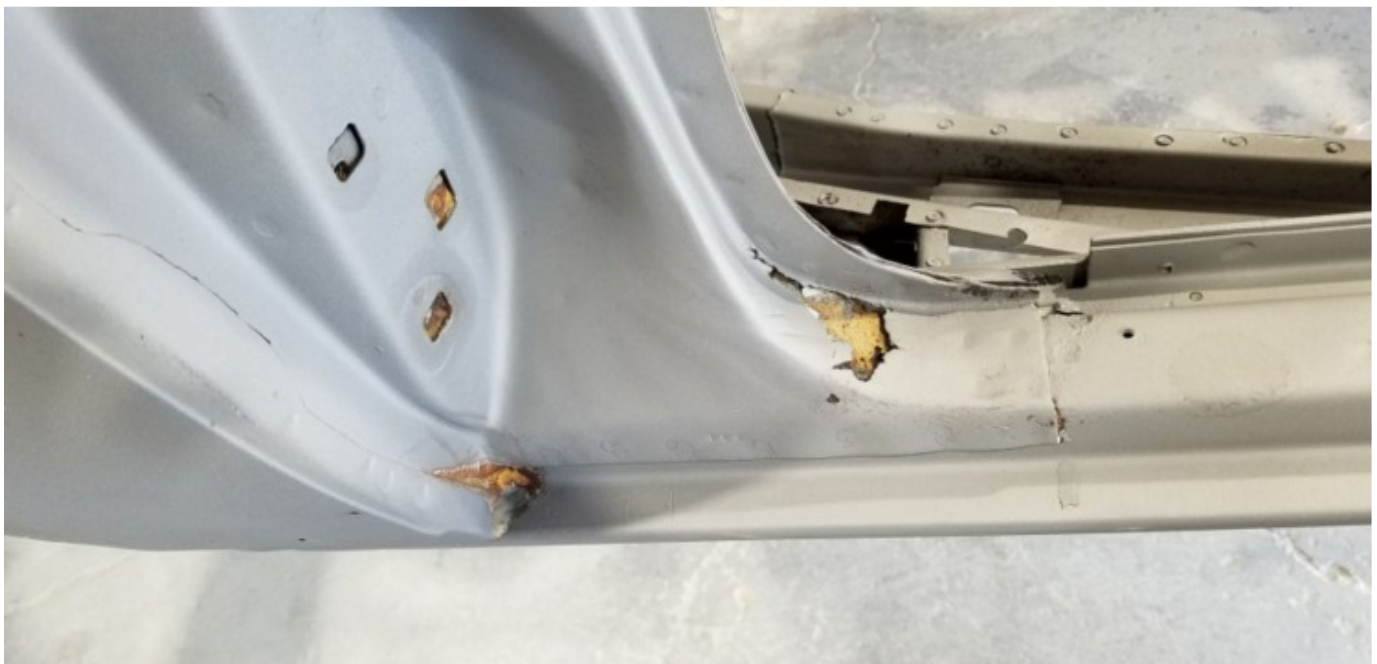
Driver's door sill corrosion, front. This area was previously covered with Bondo.

Those two badly corroded areas at the lower corners of the driver's door were cut out and replaced with original pieces from donor cars. They await final grinding and smoothing to get the seams at the proper height. Most of the right rear fender was cut away, to be replaced by a NOS piece that Duane Wentland picked up on one of his many trips to swap meets that I can't get to. The corrosion in the wheel wells of the luggage compartment still needs to be cut out and replaced, but a donor front clip will be sacrificed once the old piece is removed to be used as a template. Then the bottom of the luggage compartment can be welded in place.

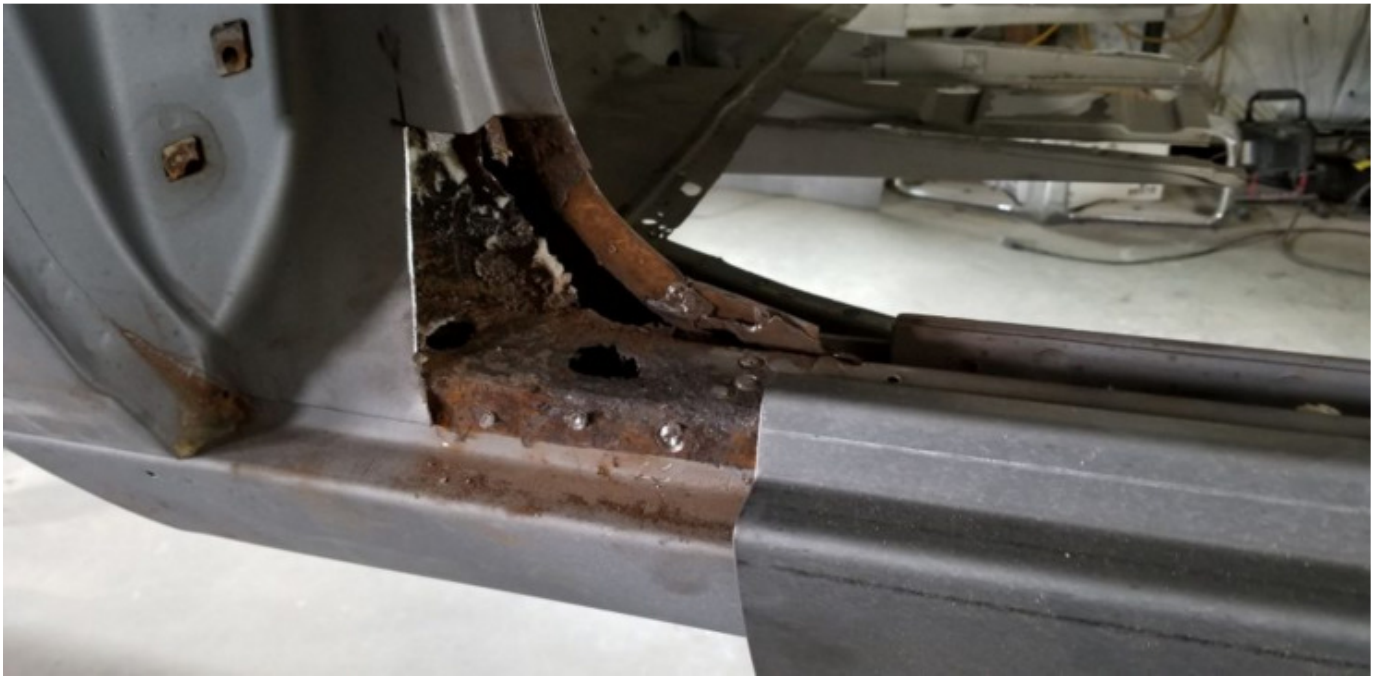
Same area, with the metal cut away for a patch panel.

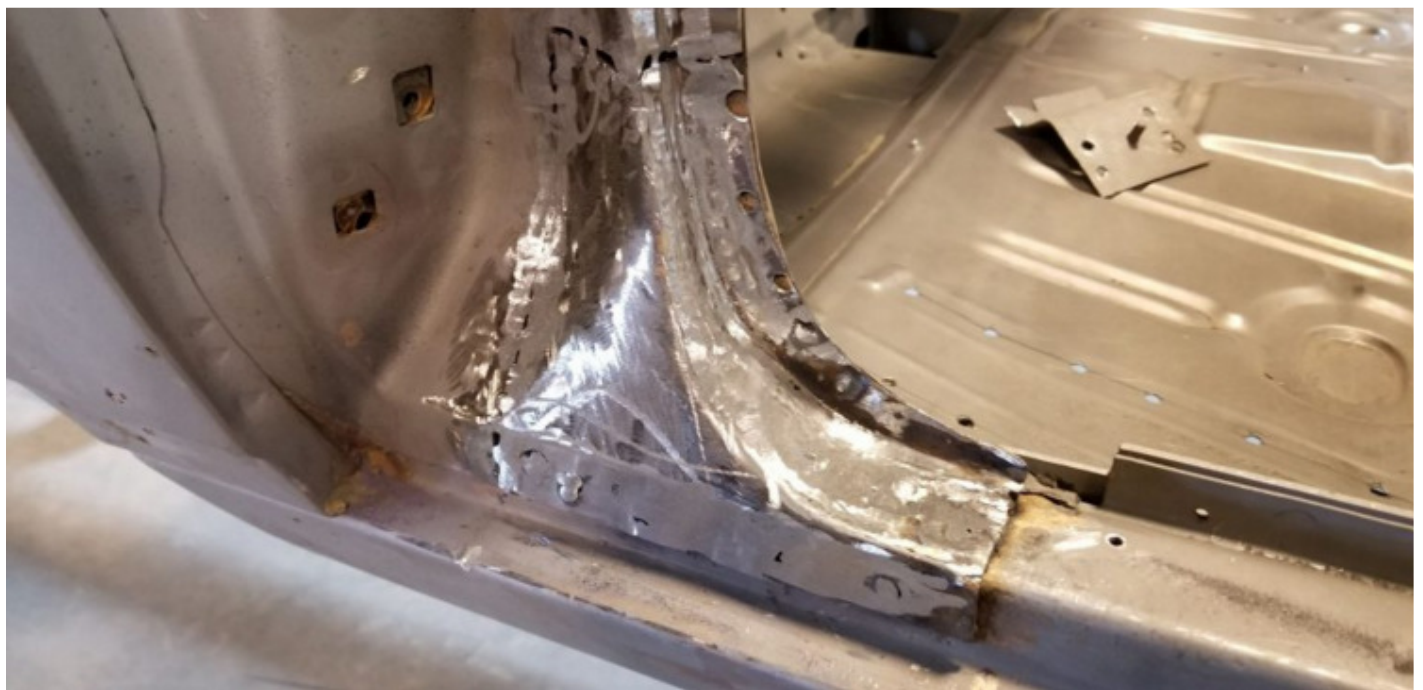
The front of the driver's door sill, with the patch panel welded in place.

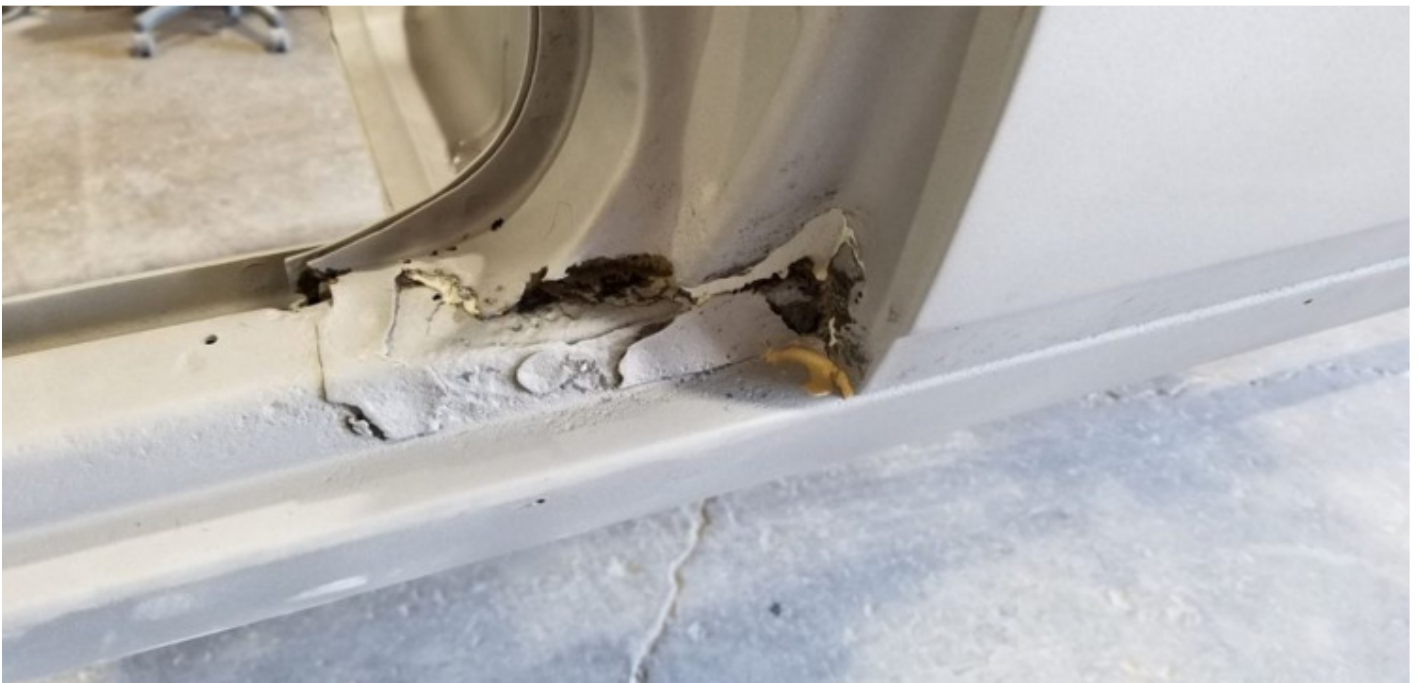
Corrosion at the rear of the driver's door sill. You guessed it – this was covered in Bondo as well.

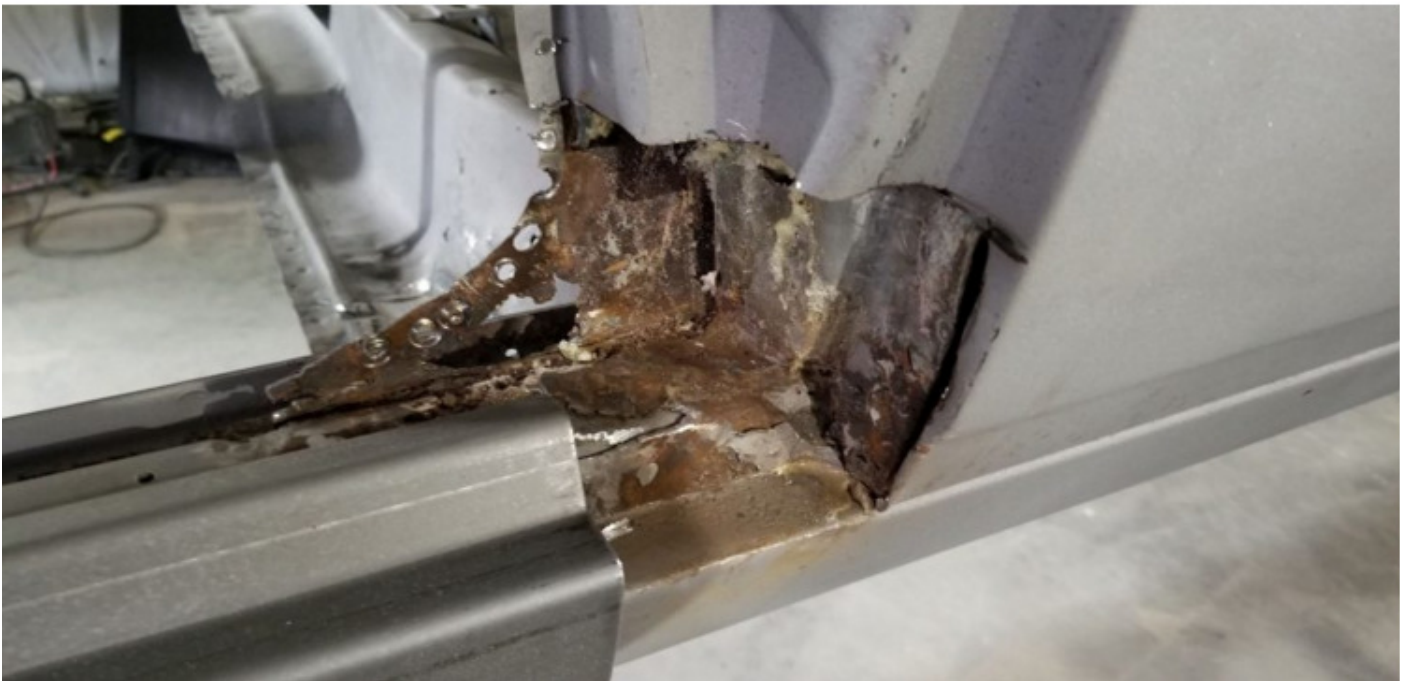
The same area, with much of the corrosion cut out.

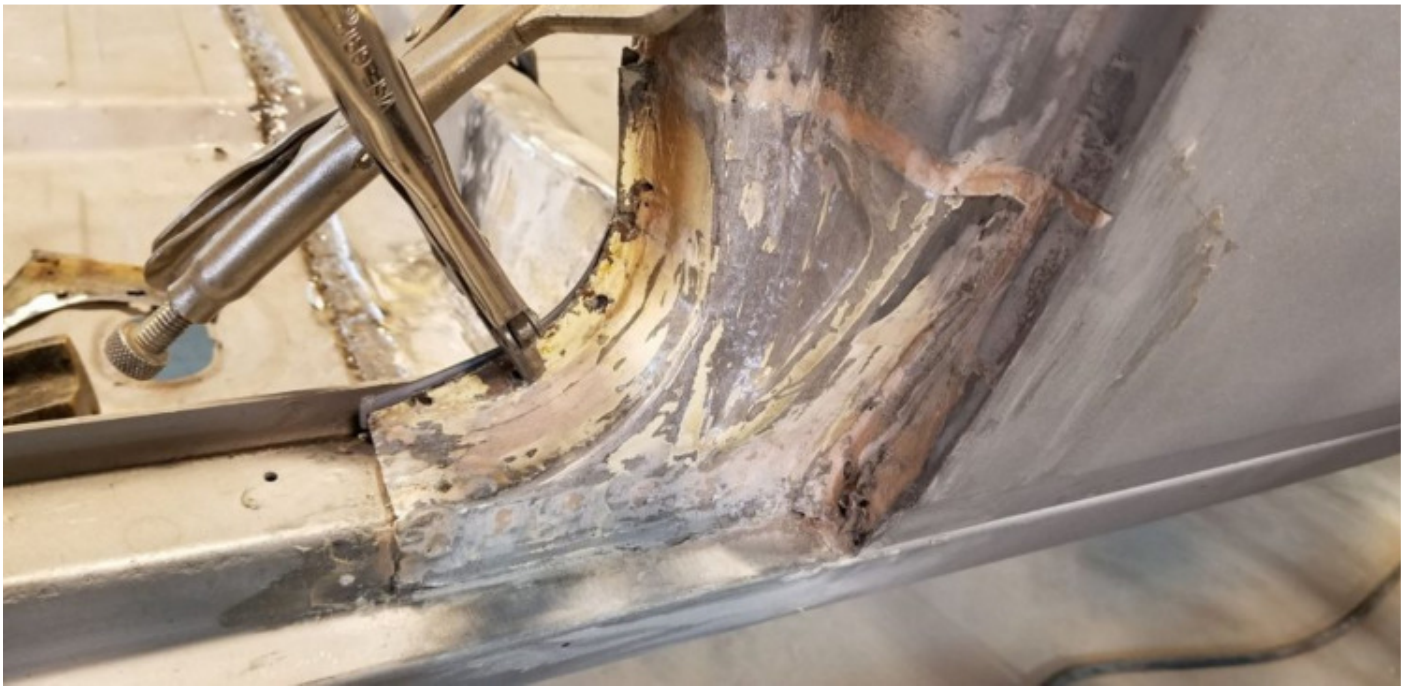
The repaired driver's door sill, rear.

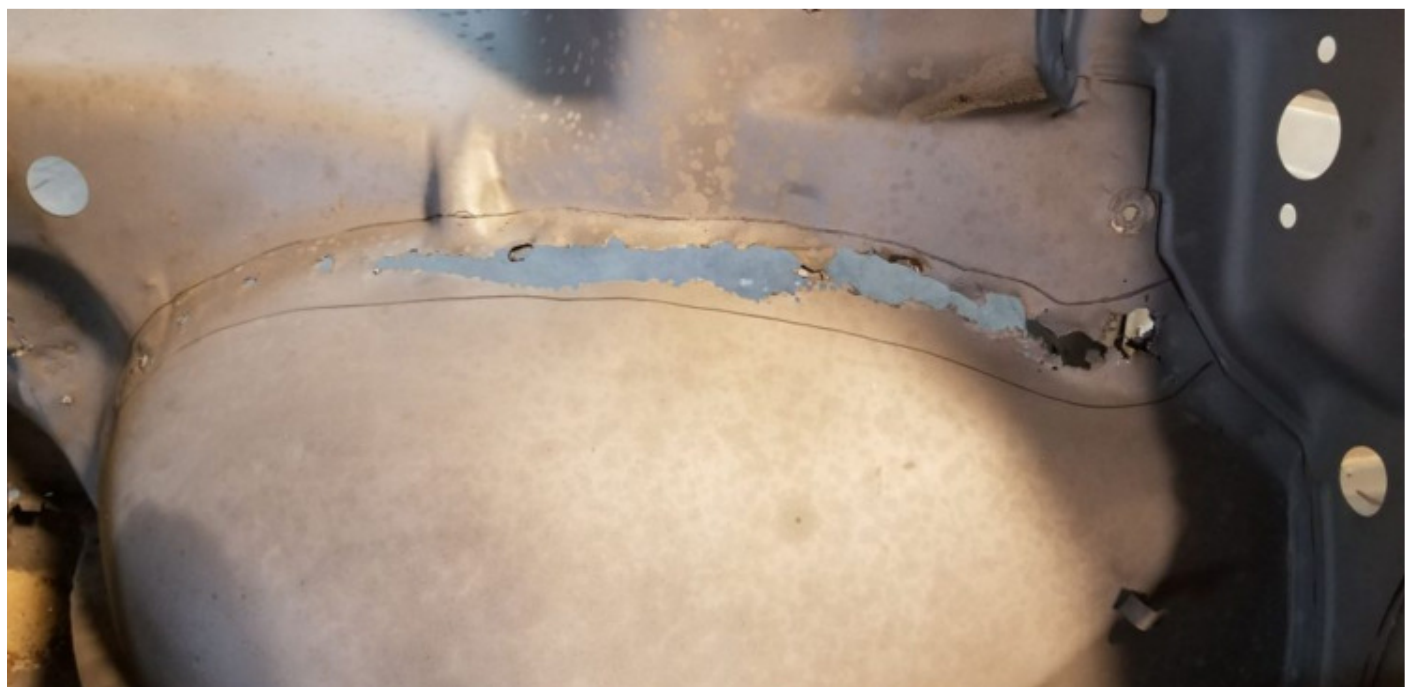
The right front wheel well, inside the luggage compartment showing what needs to be cut away and replaced.

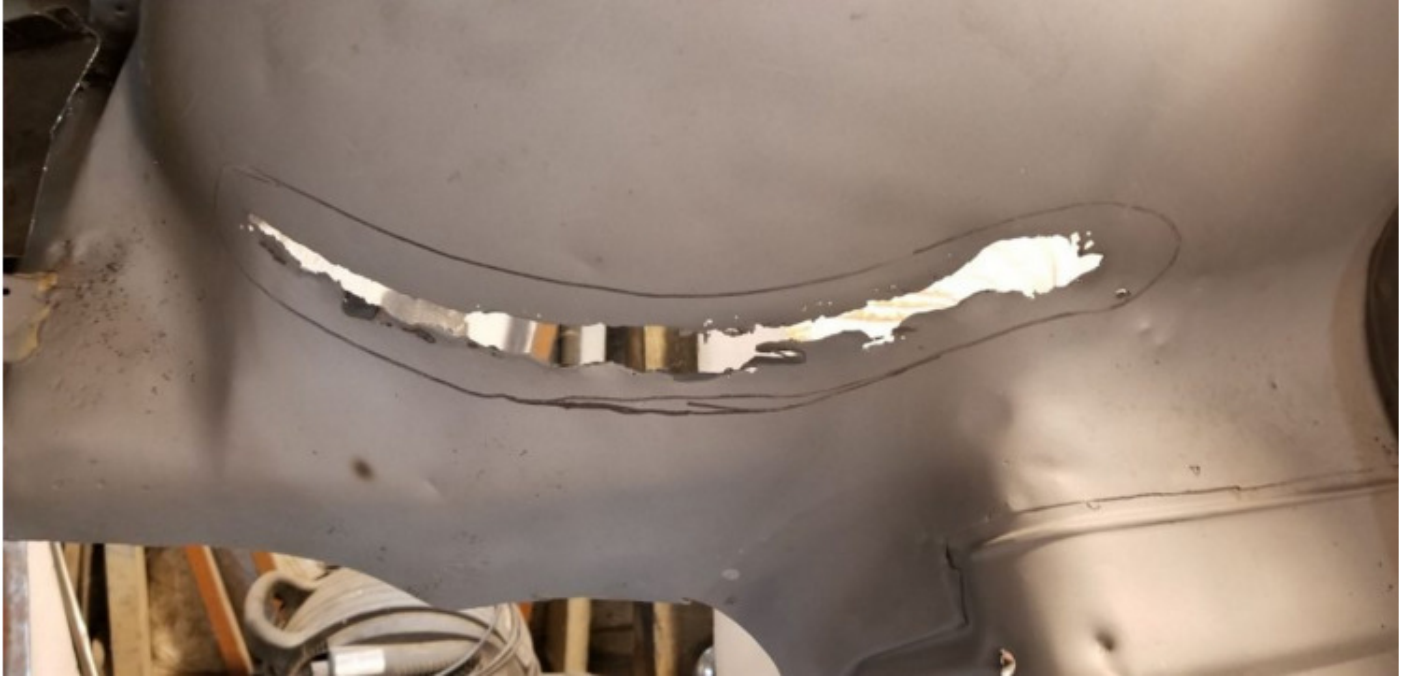
The left front wheel well showing the same.

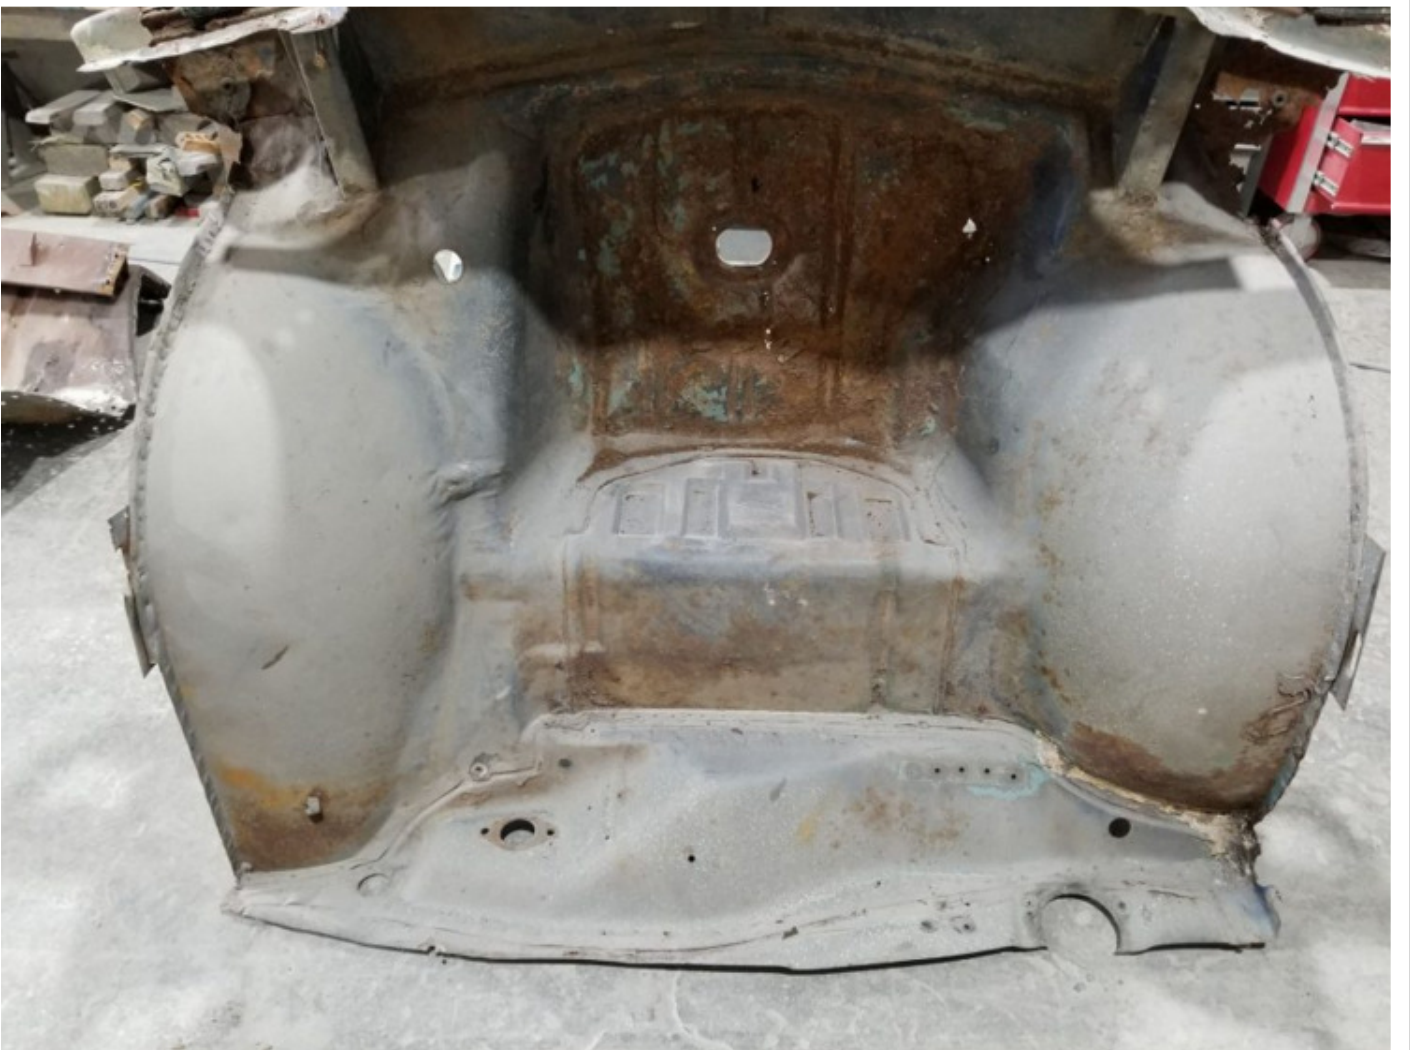
The donor front pan awaiting surgery

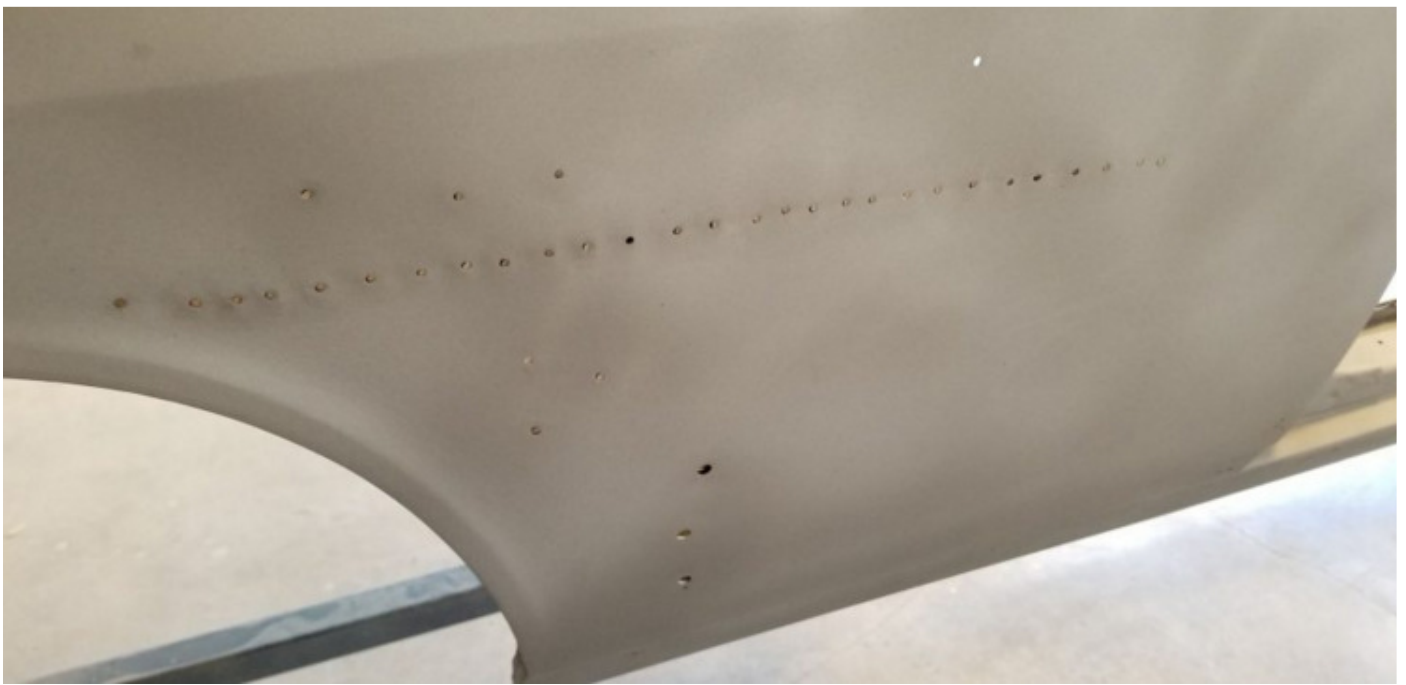
The left front fender which can still be saved.

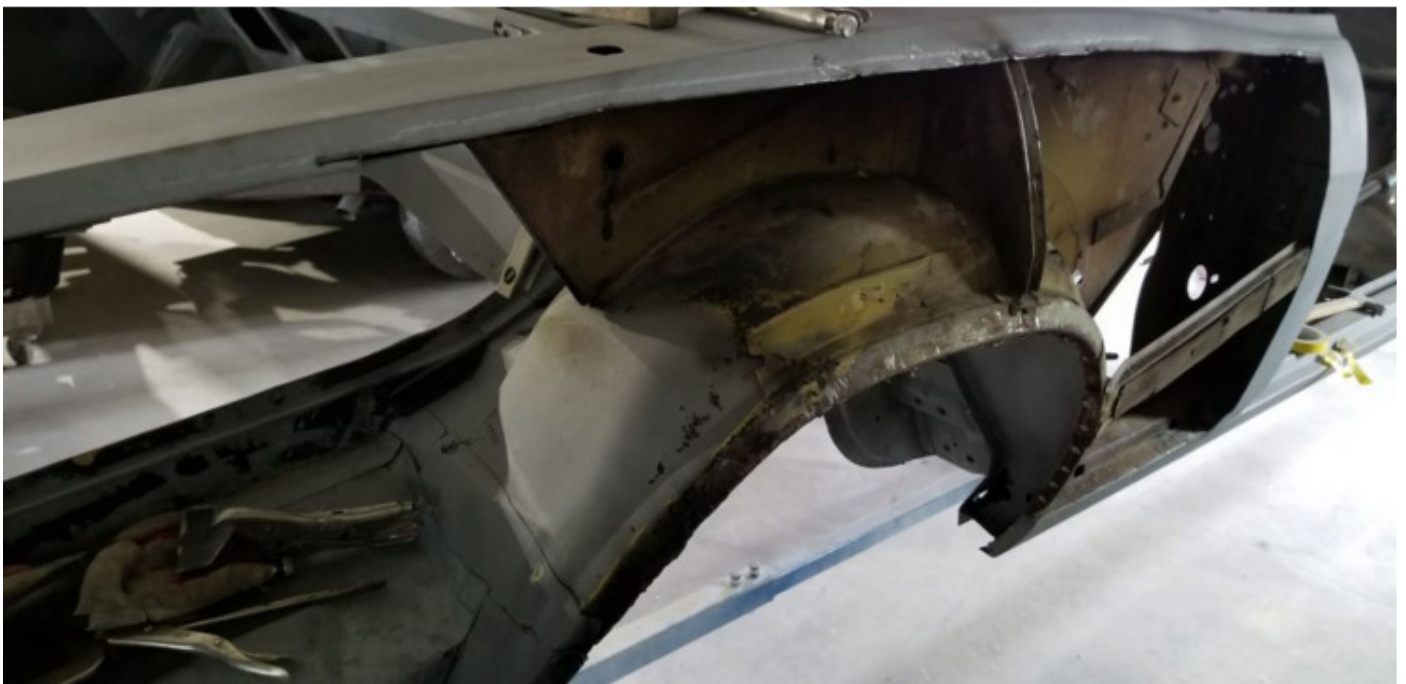
The right rear quarter panel has been cut off, awaiting a new old stock (NOS) replacement. The “repair” done by the former owner was too far gone to fix.

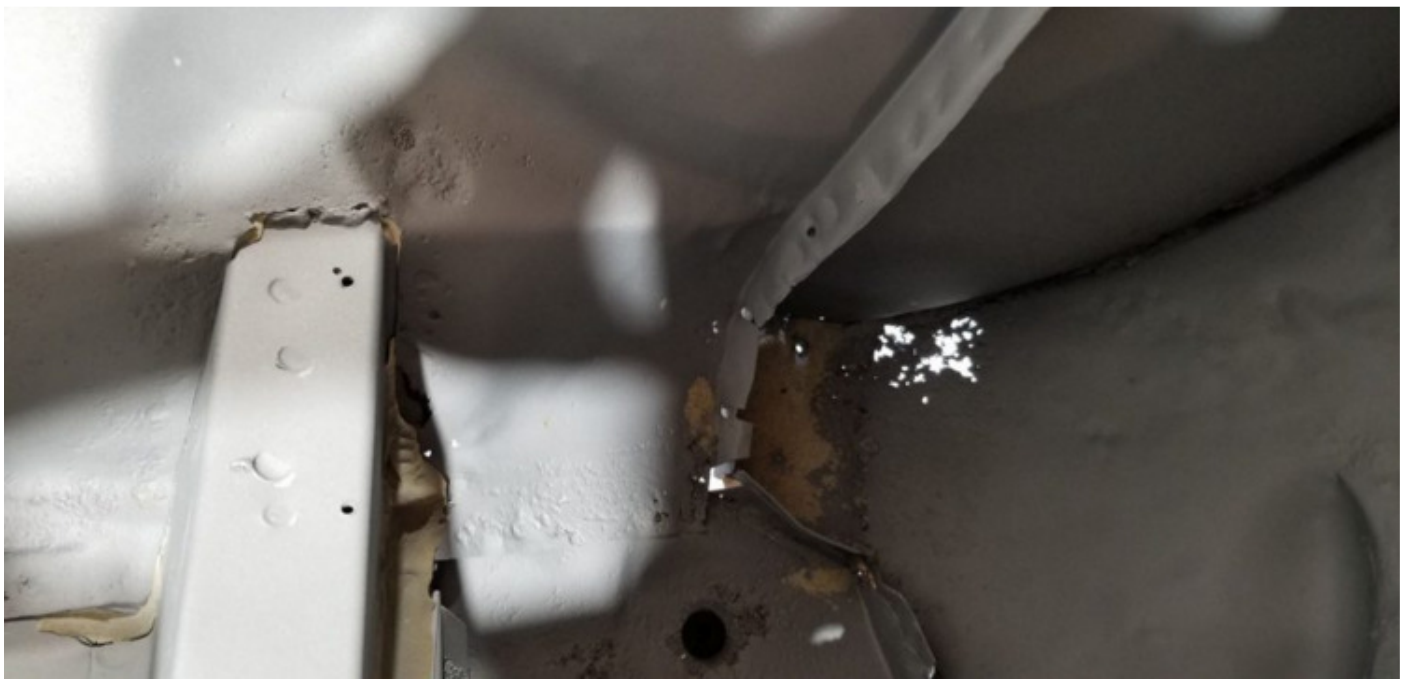
Left rear showing corrosion behind the engine.

Right rear, also behind the engine. Both areas will require patch panels.
