Rampside STRENGTH members

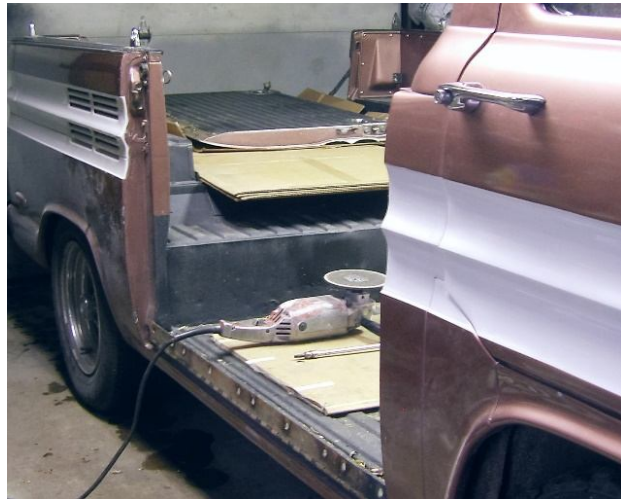
Because I had to cut open the side of my Rampside – due to perpetual rust along the bottom edge – I was able to “see” inside and figure out what it was that made that Ramp so strong.

First thing we did (son Peter was here) was to rip a hole in the side panel and bend it up to peek inside. A first time ever experience for me. Then we had to figure out how to

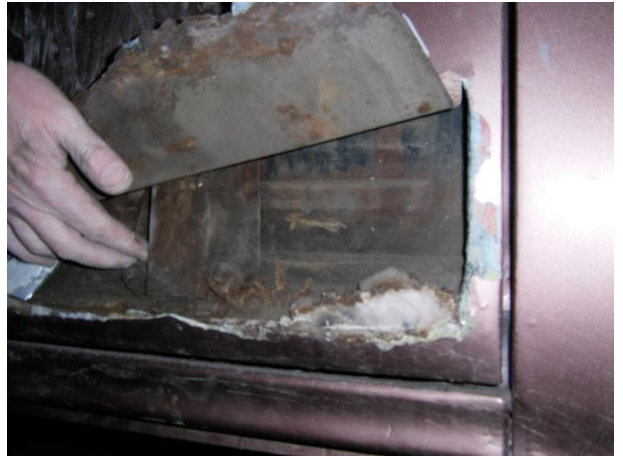
get those 50 year old bolts to let loose, without a

catastrophic outcome. We got all the bolts out, cleanly, that were screwed into the ramp. First we cut off the end of the bolt that was outside of the nut – so we wouldn't have to screw all that bad thread through the nut – then the old “smoke wrench” was applied to ‘cherry’ up the nuts. The nuts are welded to the ramp so they will remain while the heating releases the trapped in bolt.

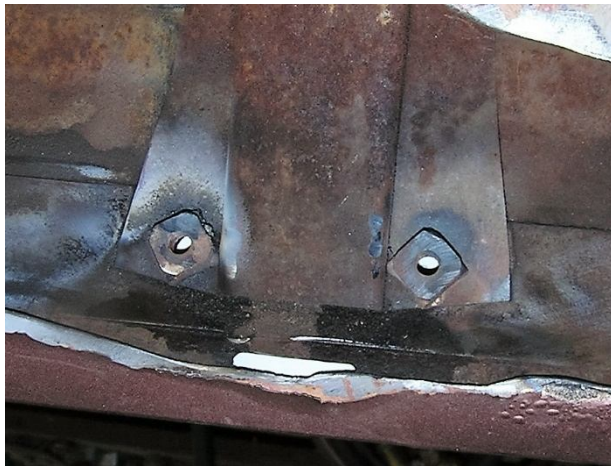
I just happened to have a clutch head tip to engage those heads...don't

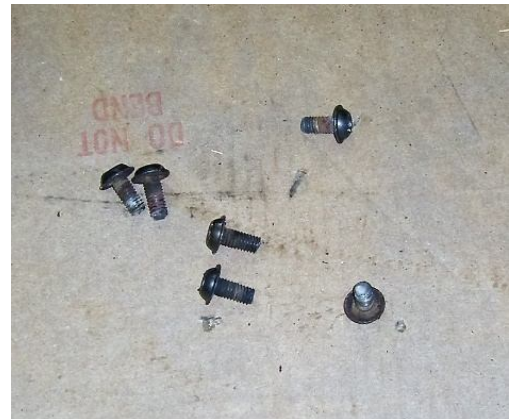
remember where I got it – probably from Clarks. With the bolts out I could take a look inside the Ramp and see the three powerful

struts mounted inside there. Along with the two ends of the box that is the Ramp there are then five structural members giving that Ramp its serious stiffness. Nice design.

Interesting to speculate why the bottom edge of that ‘box’ rusted. In the photo showing the exposed stiffener note the large drain hole right under the end of that strut. The strut is clean and the Ramp face is clean and the drain hole is clean...but the rusty line along the entire length of the Ramp is lower than the drain holes. There are three nice drain holes, but apparently not quite placed exactly right.

I intend to weld a new panel across the bottom and get it smooth and flat – as good as new!
