## 1966 Chevrolet Corvair homecoming – The good news and the bad news

[Don Homuth](#) on Mar 6th, 2019

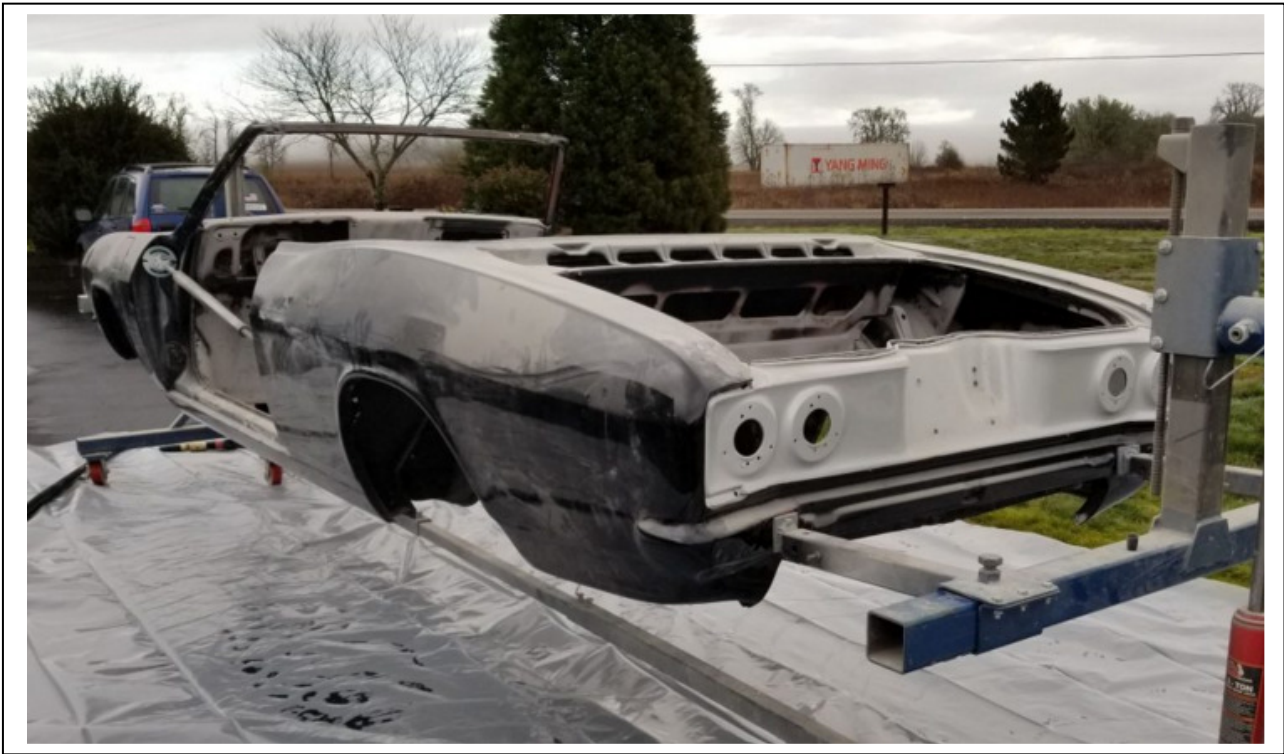
In retrospect, I should have done this two years ago. Back then, I really did hope that when the guy I bought the car from told me it was in good shape — and it looked kind of like it was — that it was the truth. That turns out not to have been the case.

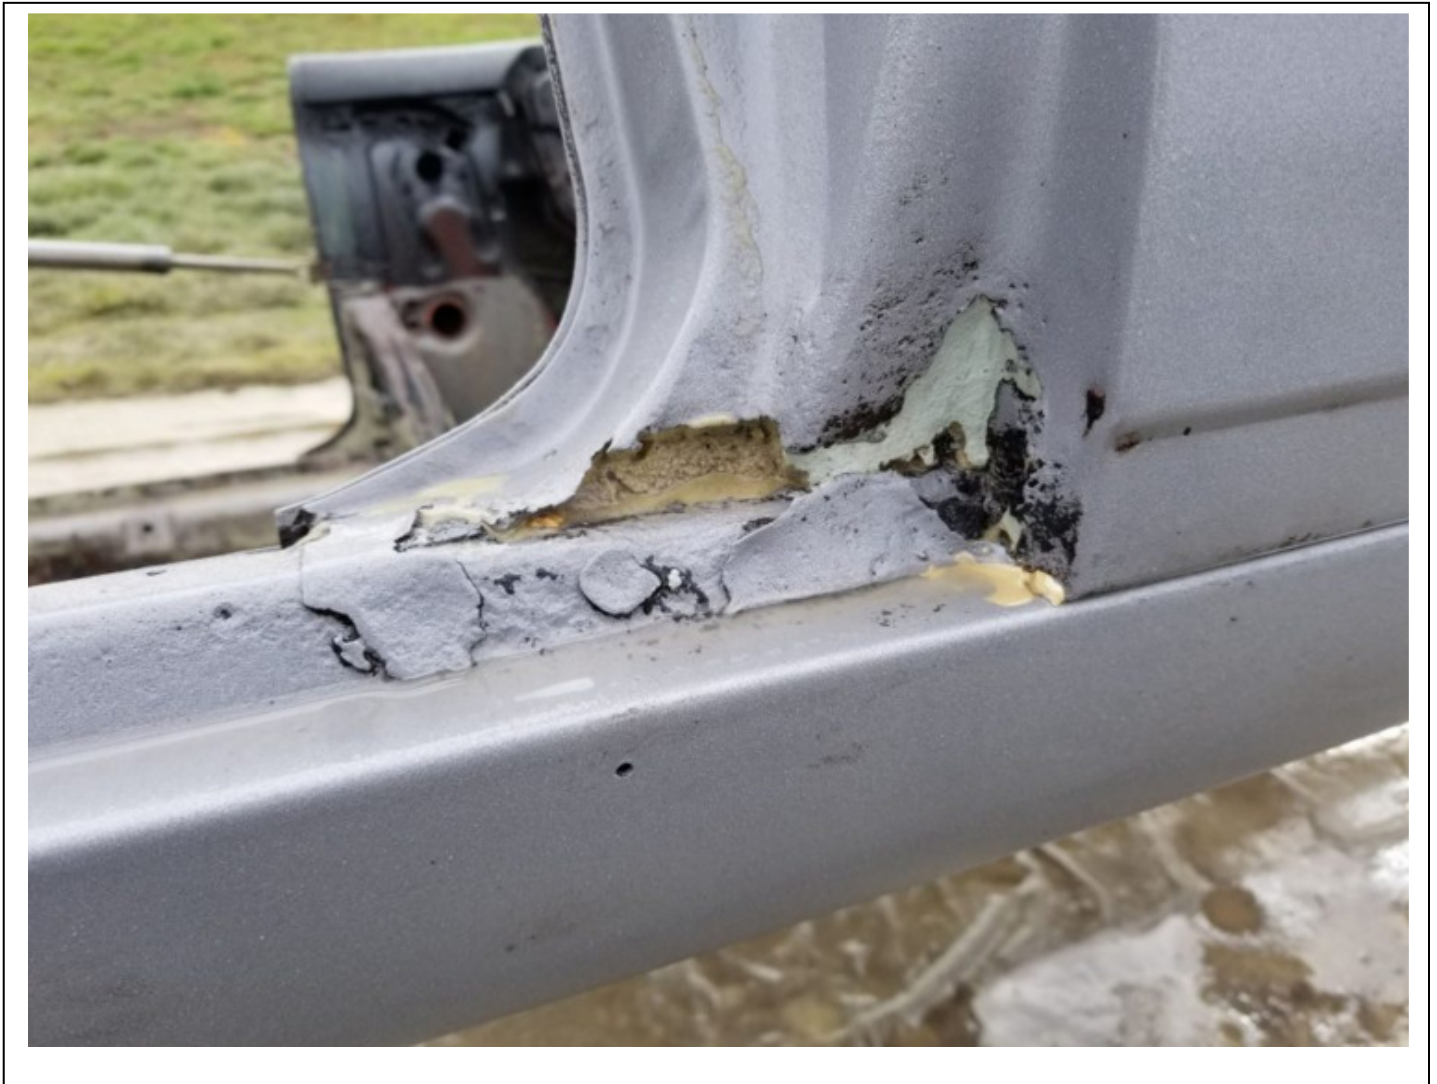
I can now clearly see all, repeat *all* of the corroded places. Many are small and can easily be fixed. Some will require new metal bits sourced from Corvair parts emporiums here and there. In a couple of months, if all goes well, the entire body will have metal where metal should be, welds where welds should be, seams where seams should be and will only then be ready for a complete refinishing inside and out. The pink Bondo and goeey yellow caulking material will be gone.
