For Sale: '65 Corsa coupe, 140, parts car

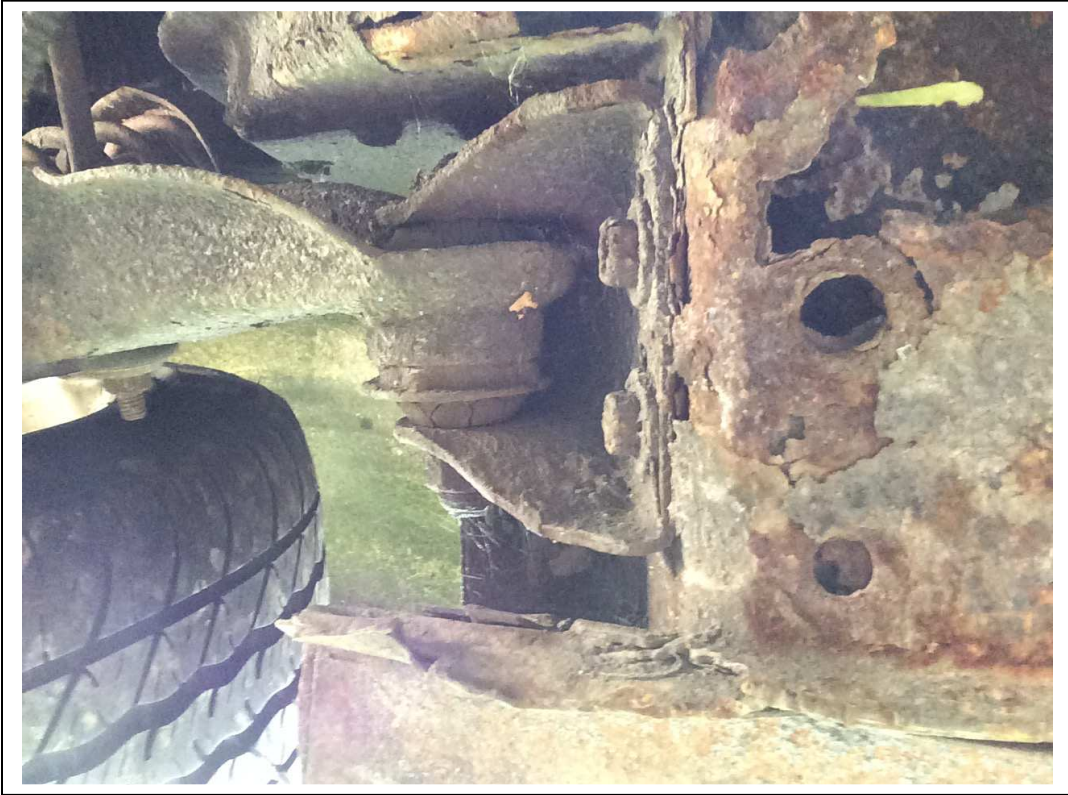
The time has come for me to say good-bye to my Corsa. Extensive rust [see ant's-eye view photo below] in the driver side rear suspension attachment point of the body makes it necessary. There is the other usual rust everywhere else [doors, behind turn signals, rear quarters, etc.] I drove it in the spring, summer, and fall for 22 years and put 90,000 miles of wonderful driving on it. I'll miss it.

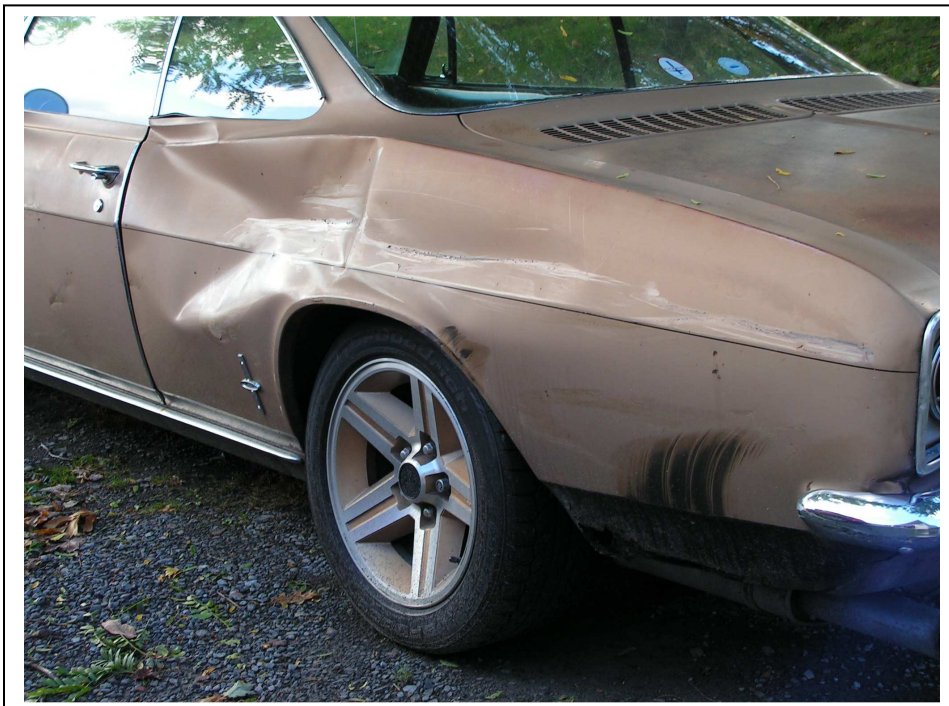
It was hit on the driver's quarter panel [see photo below] and on the passenger side quarter panel just behind the rear wheel [not shown]. These were from people pulling out of parking lots as I was driving by.
